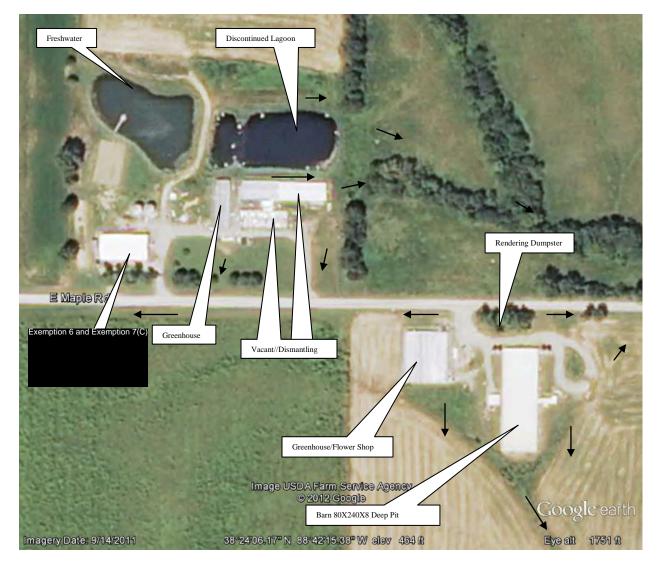
Arrows show the direction of storm water drainage. Buildings are labeled as shown. All swine operations north of Maple Road have been discontinued. On the north site, most of the eastern buildings have been disassembled and the west building is a greenhouse. The discontinued lagoon has over 4 feet of storage and closure will be ongoing through the Department of Ag. The swine barn south of Maple Road is the only production facility for the farm. The building has the dimensions shown with a corresponding under floor deep pit with a capacity of about 1.1 million gallons. Mortalities are rendered by darling and stored in a water tight dumpster where shown on the map. There was no feed or discharge noted around the perimeter of the building during the inspection on 05/18/12.
